STATE OF VERMONT Division for Historic Preservation 1 National Life Drive, Floor 6 Montpelier, VT 05602 HISTORIC SITES & STRUCTURES SURVEY Individual Property Survey Form	SURVEY NUMBER: (Assigned by VDHP)
	Listed in State Register <input type="checkbox"/> Date:
	PRESENT FORMAL NAME: 172 South Prospect Street
	ORIGINAL FORMAL NAME: Carter House
	PRESENT USE: Vacant/ not in use
COUNTY: Chittenden	ORIGINAL USE: Domestic/ single dwelling
TOWN: Burlington	ARCHITECT/ENGINEER: Unknown
ADDRESS: 172 South Prospect Street	BUILDER/CONTRACTOR: Unknown
COMMON NAME: 172 South Prospect Street	DATE BUILT: c.1830; moved to present location c.1945
PROPERTY TYPE: Building	
OWNER: University of Vermont State Agricultural College ADDRESS: c/o Campus Planning, 16 Colchester Avenue, Burlington, VT 05405	
ACCESSIBILITY TO PUBLIC: Yes <input type="checkbox"/> No <input type="checkbox"/> Restricted <input checked="" type="checkbox"/>	PHYSICAL CONDITION OF STRUCTURE: Good <input type="checkbox"/> Fair <input checked="" type="checkbox"/> Poor <input type="checkbox"/>

ADDITIONAL ARCHITECTURAL OR STRUCTURAL DESCRIPTION:

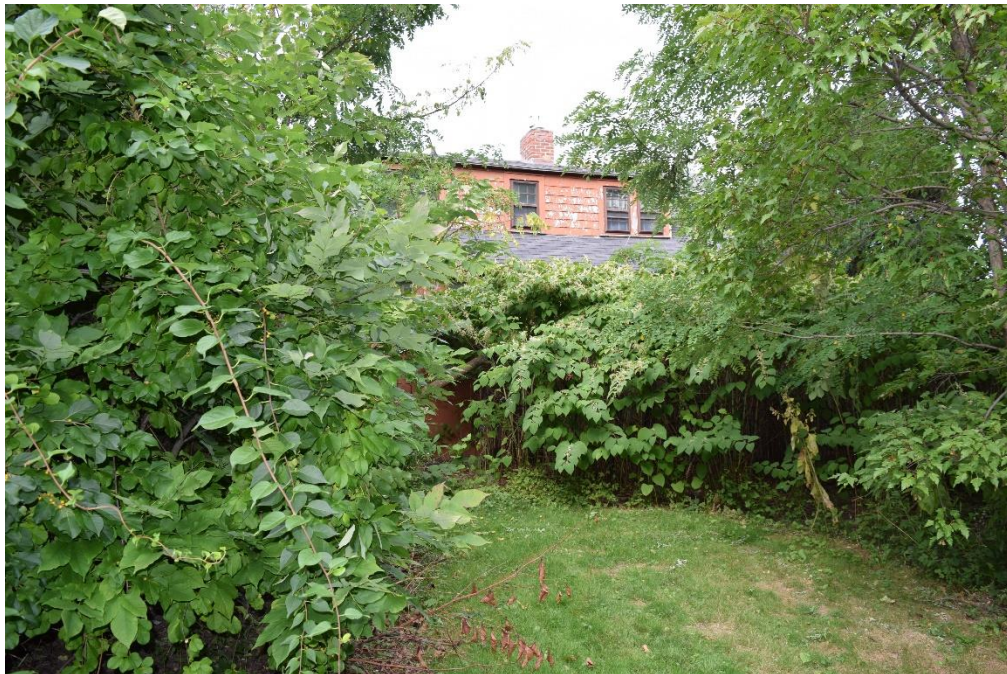
The rear (east) elevation is overgrown with invasive vegetation and therefore is not clearly visible when viewing the house. A small, gabled bulkhead accessing the basement stairs is located at the rear of the house. A small, wooden deck with wood steps accesses a rear entrance on the south side of the rear elevation which contains a 15-light door. A second wooden deck is located on the north side of the rear elevation, accessed from the interior by a set of 15-light, sliding doors. A set of paired, 6/6, wooden sash windows is centrally located on the east elevation. A broad, shed-roof dormer is found on the east side of the roof containing a central, 6/6 wooden sash window and a set of paired, 6/6 wooden sash windows on either end of the dormer.

Photograph 5: East (rear) elevation of house, facing west. Note the overgrown vegetation obscuring this side of the house.

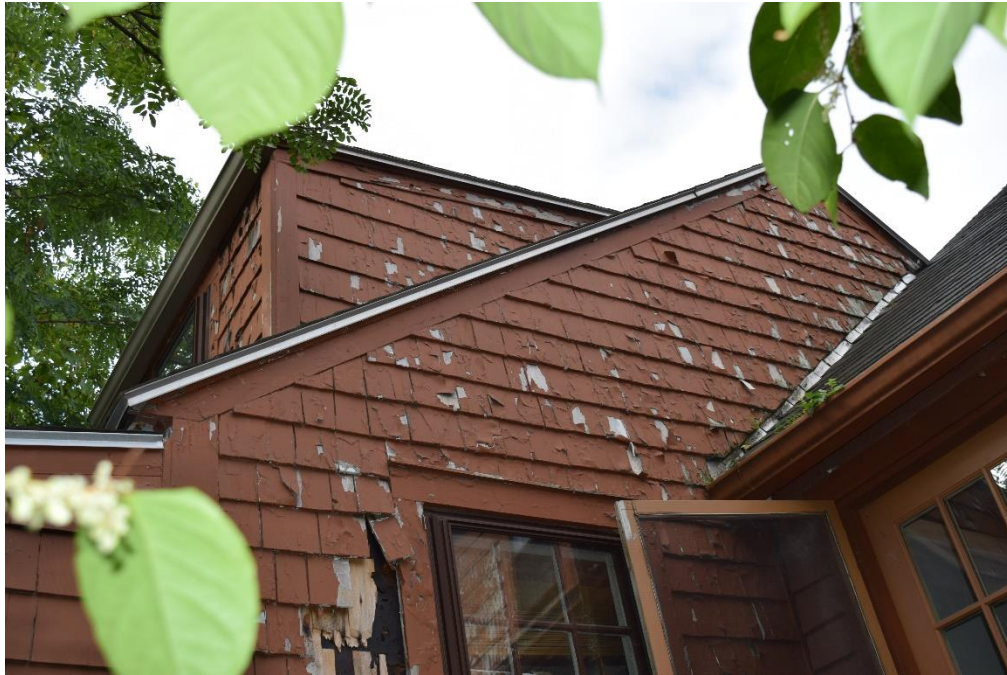
UVM purchased the house in 2006, after the Carter family moved out. For three years, it was used as temporary housing for UVM faculty. After it was vacated in about 2009, the heat was turned off but not the water; during the winter, all of the pipes burst in the house, resulting in extensive damage throughout the interior and exterior. Ice dams formed on the exterior of the house, which led to the damage in the siding seen today. Since this flooding incident, the house has remained vacant.

Photograph 8: North elevation of south wing, facing south-southeast. Note the shed roof dormer, deteriorated siding, and rear elevation entrance at lower right.

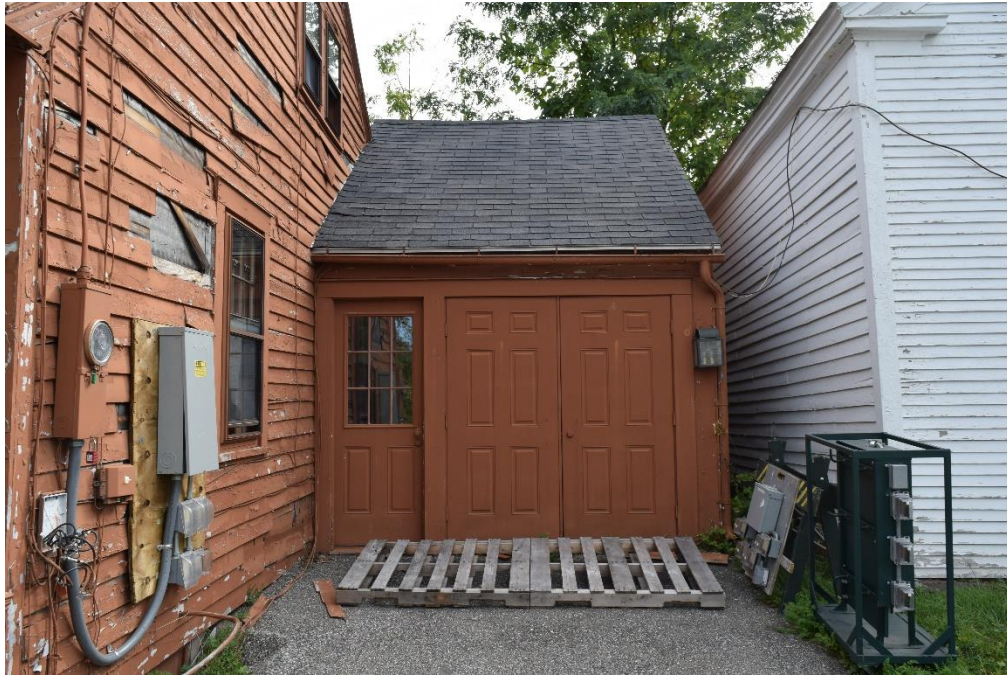
Photograph 10: West elevation of south wing, facing east. Note the deteriorated siding on the south elevation at left and the barn at 178 S. Prospect Street at right.

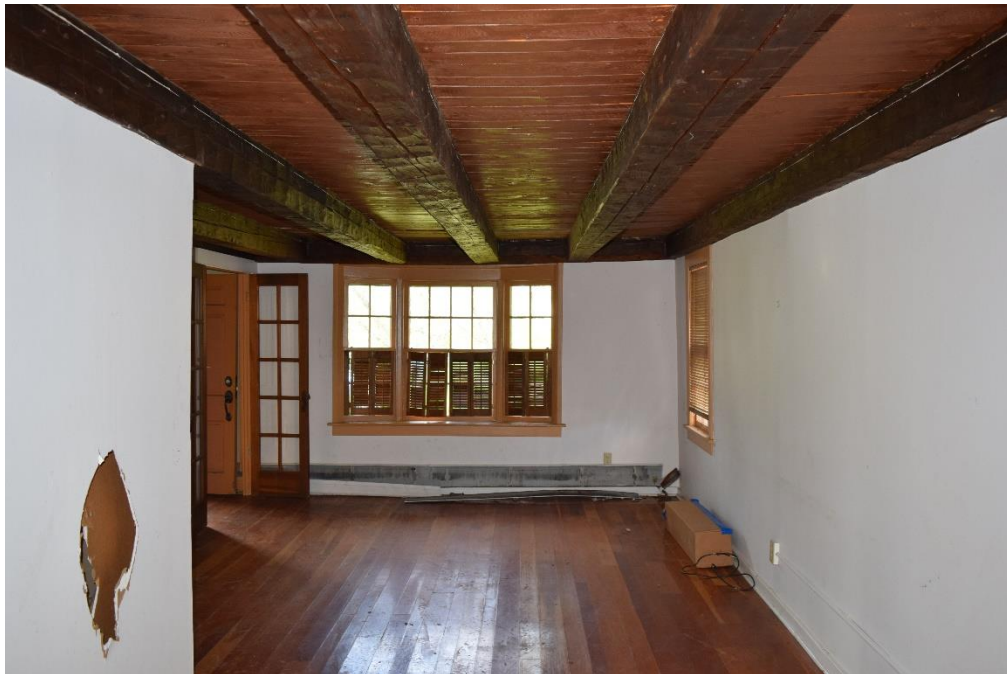
The interior of the house is currently uninhabitable due to extensive deterioration and rodent infestation. Due to burst pipes and flooding in 2009, the walls are filled with holes where the pipes were taken out. Finishes throughout are deteriorated, and the kitchen lacks a sink and appliances.

Photograph 11: Interior of parlor, looking west towards one of the bay windows on the primary façade. Note the hand-hewn ceiling beams and hole in the wall at left where pipes were removed.
